# Experimental Evaluation of Precast Channel Bridges

## ABSTRACT

The precast channel bridge (PCB) is a short span bridge that was commonly used on Iowa's secondary roads approximately forty years ago. Each PCB consists of eight to ten simply supported precast panels ranging in length from 5.8m to 11.0m. The panels resemble a steel channel in cross-section; the web is orientated horizontally and forms the roadway deck and the legs act as shallow beams. Bundled reinforcing bars in each leg act as the primary flexural reinforcement.

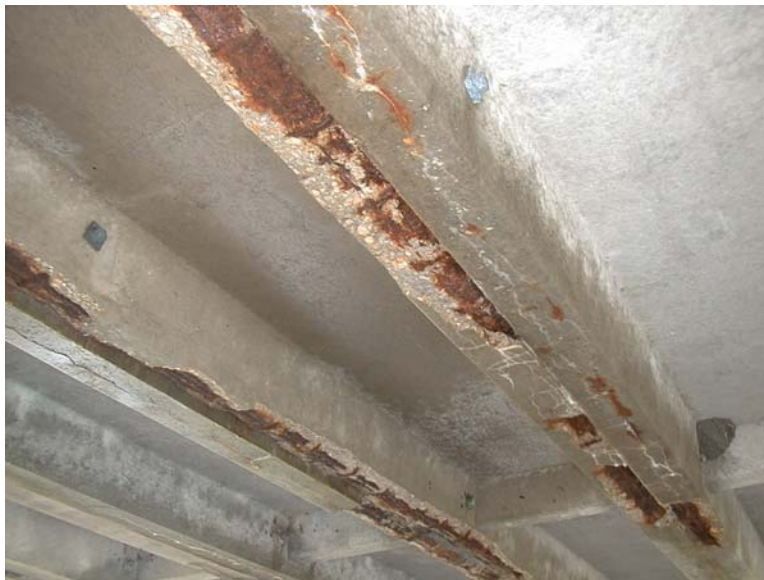
Many of Iowa's PCBs are heavily deteriorated. Typical deterioration consists of spalled concrete and significant corrosion of the primary reinforcing steel. In many cases, as shown in Figure 4, the bottom bars in a stem are exposed over almost the entire span. In other cases, longitudinal cracks and rust stains are often found on the bottom and side of the panel stems. The effects of this deterioration, such as loss of cross-sectional reinforcement area and bond, have led to concerns over the ability of a deteriorated PCB to safely support legal loads.

**FIGURE 4. Typical PCB Deterioration**

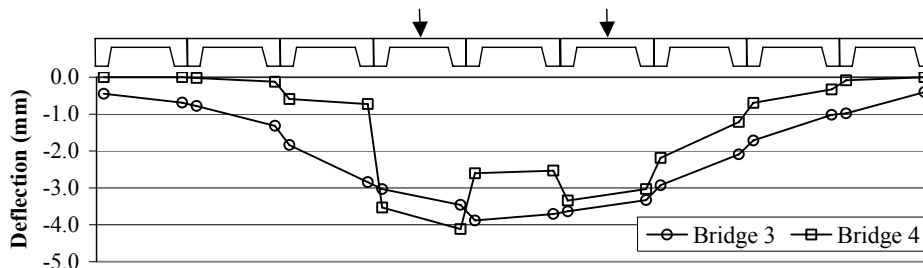
The load fractions varied greatly from bridge to bridge. This was due to variations in the connections between adjacent panels. Inspection of all four bridges revealed that the concrete-filled pipes were not in place on Bridge 2 and grout was not packed in the keyways on Bridge 4. The keyways on Bridge 4 contained only gravel from the gravel wearing surface.

The effectiveness of these shear connectors is graphically show in Figure 5. This plot shows midspan deflection for Bridge 3 and 4 when the center lane was loaded. As one can see, the grout in the keyways of Bridge 3 prevented differential displacement across the panel joints. When the keyways were not grouted, significant joint slip occurred. Also, rigid joints transfer more load to neighboring panels and thus the load fractions for Bridge 3 were less than the load fractions for Bridge 4.

**FIGURE 5. Transverse Centerline Deflections: Center Lane Loading**

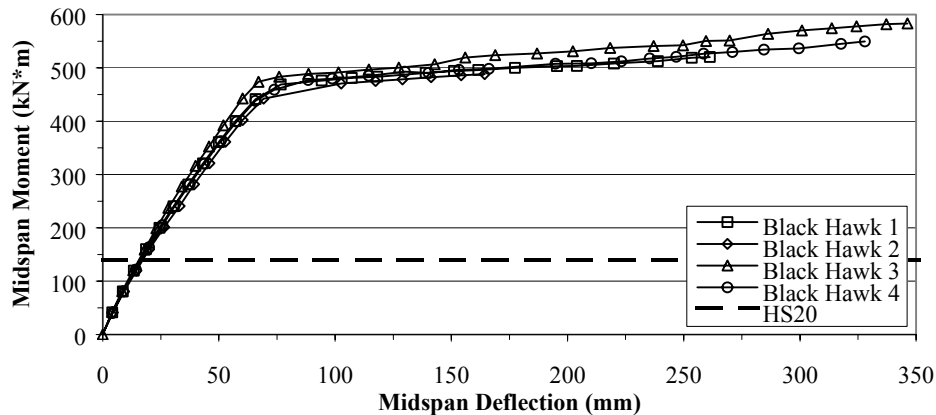
Midspan moment verses midspan deflection plots for the Black Hawk PCB panels are presented in Figure 6. As one can see, well defined regions of elastic and plastic behavior existed. This behavior was typical for all PCB panels tested. Elastic behavior occurred up to the point when the stress in the primary reinforcing exceeded its yield stress. The panels then deflected excessively while supporting only a small increase in load. This behavior continued until a compression failure occurred in the deck. Also shown in Figure 6 is the midspan moment induced by AASHTO HS20 loading. The magnitude of this loading is well within the elastic range and is considerably less than the ultimate strength of these panels.

**FIGURE 6. Moment Verses Deflection Plots For Black Hawk Beams**
