# Repair of Damaged Prestressed Concrete Bridges Using CFRP

**F. Wayne Klaiber, Terry J. Wipf**

## ABSTRACT

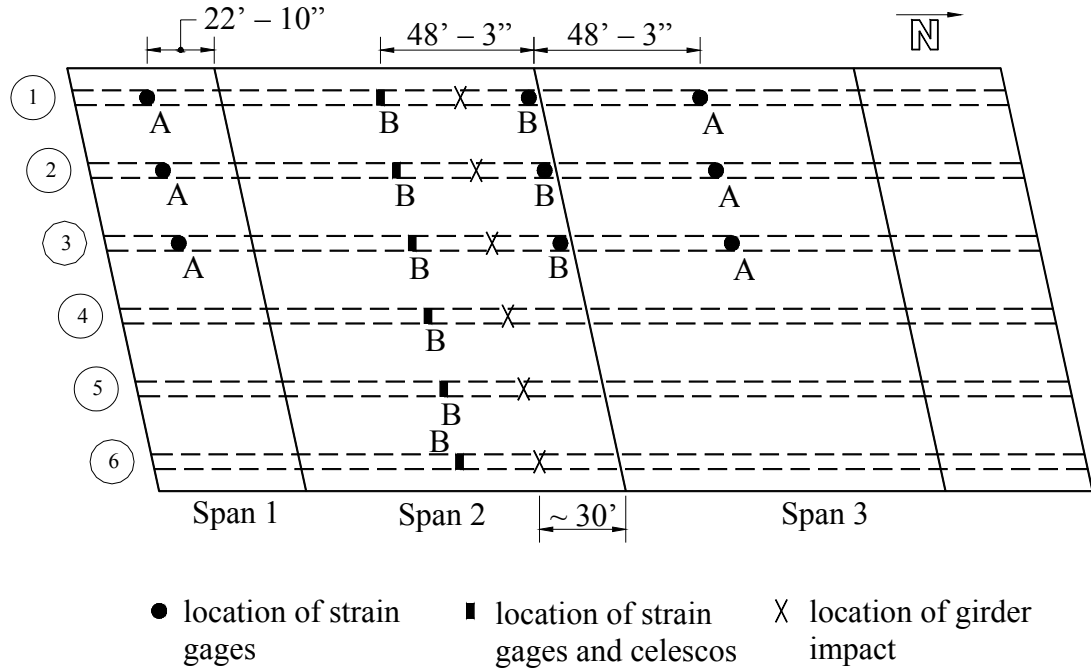
**FIGURE 2. Location of Damage, Strain Gages, and Deflection Transducers on the Altoona Bridge**

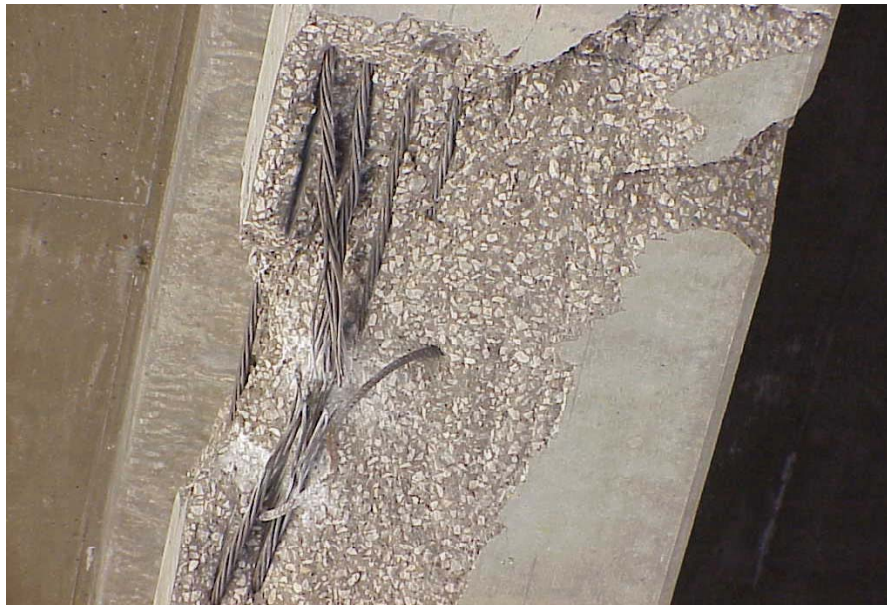
The bridge that was damaged was on the south bound portion of the IA Highway 65 bridge that crosses IA Highway 6 in the vicinity of Altoona, Iowa. This four span bridge consists of two 96.5 ft main spans and two approach spans – the north one 36 ft long and the south one 46 ft long. A cross-section of this bridge is presented in Fig. 1. All six of the LXD P/C girders in one of the main spans were damaged by an overheight vehicle traveling east on IA Highway 6. Although, as illustrated in Fig. 2, all 6 girders were damaged approximately 30 ft from the center pier, most of the damage was to the first two girders. Damage to Beam 1 consisted of spalling of concrete from the bottom flange and the severing of one strand. Damage to Beam 2 (shown in Fig. 3) was the most severe in that significantly more concrete spalled from the bottom flange exposing five strands two of which were severed.

**FIGURE 3. Photograph of the Damage to Beam 2 in the Altoona Bridge**

Prior to installation of the CFRP, the manufacturer's recommended patching material and procedures were used to repair the spalled concrete on the various beams, CFRP plates were attached to the most heavily damaged beam – Beam 2 after the patch material had cured. Four 4-in. wide by 75 ft long protruded CFRP laminates (shown in Fig. 4) were installed on the bottom flange of Beam 2 using an epoxy-resin which was applied to both the laminate and the P/C girder. A rubber roller was used to enhance the bond. The tensile design strength of the CFRP laminates was 406 ksi. After installation of the four laminates, a CFRP wrap was installed in the vicinity of the patch (80 in. of the girder was wrapped) to confine the patch and to prevent any plate debonding. Five CFRP strips (approximately 6 ft long which was sufficient length to cover the bottom flange and all but approximately the top 1 in. of the web) were installed. Similar CFRP sheets were installed at the location of the patches in the other beams to assist in confining the patches.

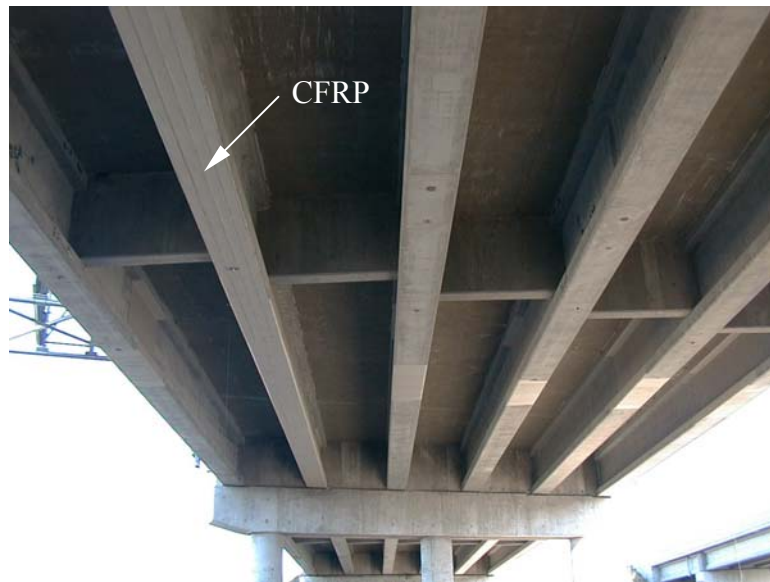
**FIGURE 4. Photograph of CFRP on Beam 2 of Altoona Bridge**

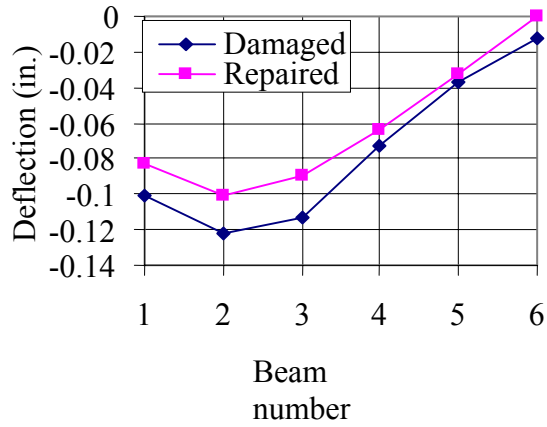
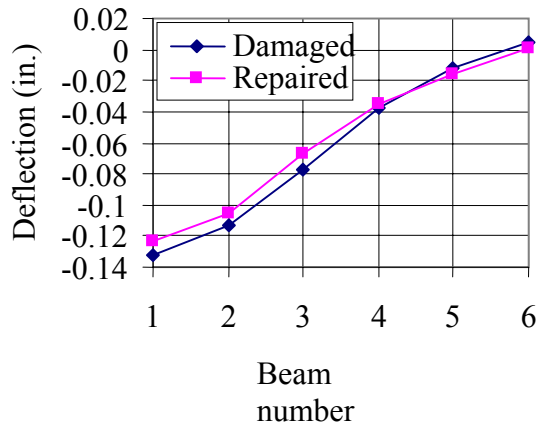
FIGURE 5. Comparison of LC1 deflections in Altoona Bridge

FIGURE 6. Comparison of LC2 deflections in Altoona Bridge

The effect of the CFRP strengthening system is apparent in both Figs. 5 and 6. After the CFRP was installed (which increased the moment of inertia of Beam 2 by approximately 5 percent), deflections at the midspan of Span 2 decreased for both LC1 and LC2. Strains in Beam 2 due to the slight increase Beam 2 stiffness increased a small amount but were still in the 50-60 MII range.
