# Performance of SPS-1 Project in Kansas

The Long-Term Pavement Performance (LTPP) SPS-1 experiment entitled “Strategic Study of Structural Factors for Flexible Pavements” was developed to determine and evaluate the factors affecting the performance of flexible pavements. The experimental design was aimed at determining the effects of following specific pavement design features: (1) base type, (2) base thickness, (3) pavement thickness, and (4) in-pavement drainage systems. The SPS-1 experimental project in Kansas, constructed in 1993, was located in the eastbound driving lane of US-54, a major rural arterial. The experiment consisted of 12 standard SPS-1 sections, 1 Kansas DOT (KDOT) control section, and 5 supplemental sections. The service life of these sections was estimated by KDOT to be from 2 to 120 years. However, because of premature distresses, some sections were rehabilitated in 1996 and 1997. This paper discusses causes of premature distresses on some sections and the performance of other sections.

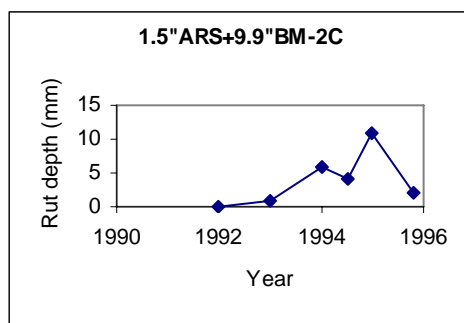
Figure 3. Rutting on section KDOT #3

Soon after construction was completed, two sections with an ARS, KDOT #3 and KDOT #5, started to show the first signs of rutting (Gisi and Dietz 1997). The severity of rutting varied from section to section. Sections SHRP #1 (7.6-in. BM-1B/8.5-in. DGAB), SHRP #2 (4-in. BM-1B/12.3-in. DGAB), SHRP #4 (4.1-in. BM-1B/4.1-in. PATB/3.7-in. DGAB), KDOT #1 (1.5-in. BM-1B/4-in. BM-2C/7-in. DGAB/GG), and KDOT #2 (1.5-in. BM-1B/4-in. BM-2C/11-in. DGAB) were experiencing one-dimensional consolidation (densification)-type of rutting. This may indicate rutting in any or all layers of the sections.

Some of the rutting in section KDOT #3 (1.5-in. ARS/9.9-in. BM-2C) was due to densification of the ARS on the wheel path, but not all was associated with it. Hot weather during the summer also contributed to rutting on this section. Rutting in section KDOT #6 (1.5-in. ARS/2.5-in. ARB/8-in. BM-2C) was due to an unstable base and ARS densification in the wheel paths. Some of the rutting in sections SHRP #1 (7.6-in. BM-1B/8.5-in. DGAB) and SHRP #2 (4-in. BM-1B/12.3-in. DGAB) was due to asphalt mixture densification on the wheel paths, and some of the rutting in SHRP #2 (4-in. BM-1B/12.3-in. DGAB) was attributed to poor subgrade compaction. These sections were repaired primarily by milling and overlay (mill 4 inches and inlay with 4 inches of BM-2). Figures 3 through 10 show the measured rut depth trends on some of the sections up to 1996.

Sections KDOT #3 (1.5-in. ARS/9.9-in. BM-2C) and KDOT #5 (1.5-in. ARS/2.5-in. ARB/8-in. DGAB) were milled and overlaid in December of 1995. Test sections KDOT #6 (1.5-in. ARS/2.5-in. ARB/8-in. BM-2C), SHRP #1 (7.6-in. BM-1B/8.5-in. DGAB), SHRP #2 (4-in. BM-1B/12.3-in. DGAB), and SHRP #4 (4.1-in. BM-1B/4.1-in. PATB/3.7-in. GAB) showed signs of rutting along with block cracking and were repaired in the summer of 1996.

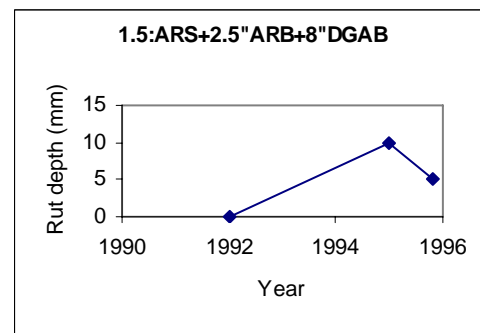
Figure 4. Rutting on section KDOT #5

Sections KDOT #1 (1.5-in. BM-1B/4-in. BM-2C/7-in. DGAB/GG) and KDOT #2 (1.5-in. BM-1B/4-in. BM-2C /11-in. DGAB) had rutting in the wheel paths with ride quality in some areas being affected. Sections KDOT #3 (1.5-in. ARS/9.9-in. BM-2C), KDOT #5 (1.5-in. ARS/2.5-in. ARB/8-in. DGAB), and KDOT #6 (1.5-in. ARS/2.5-in. ARB/8-in. BM-2C), which are the KDOT asphalt rubber sections, had consolidation as well as lateral movement of asphalt mixture materials (shear displacement).

Stability tests were performed after the permeability tests. Cores with low permeability were remixed and compacted to the nearest field density by the Corps of Engineers Gyratory Testing Machine (GTM). The GTM results are useful for identifying mixtures susceptible to localized shear failure or lateral movement of hot-mix asphalt material. A gyratory stability index (GSI) was measured from the plot of the compaction curve by empirically relating the number of revolutions required to reproduce the in-place density. If the GSI value exceeds one, the mix is unstable on the rich side of the compaction curve, and progressive rutting would occur under hot weather conditions. The results showed that the ARB mix in section KDOT #5 (1.5-in. ARS/2.5-in. ARB/8-in. DGAB) and the BM-1B and BM-2C mixes in section

KDOT #1 (1.5-in. BM-1B/4-in. BM-2C/7-in. DGAB) were unstable and might have contributed to rutting on these sections.

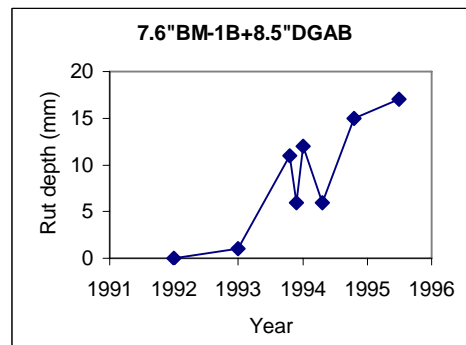
Figure 6. Rutting on section SHRP #1

Sections SHRP #1 (7.6-in. BM-1B/8.5-in. DGAB), SHRP #2 (4-in. BM-1B/12.3-in. DGAB), and SHRP #4 (4.1-in. BM-1B/4.1-in. PATB/3.7-in. DGAB) indicated rutting as well as map or alligator cracking. Section SHRP #2 (4-in. BM-1B/12.3-in. DGAB) had one-inch-deep ruts in both wheel paths in 1996. It was suggested that a four-inch mill and inlay be used if the deterioration continued. The deficiencies mentioned above were summarized by the KDOT Geotechnical Unit in Table 3.

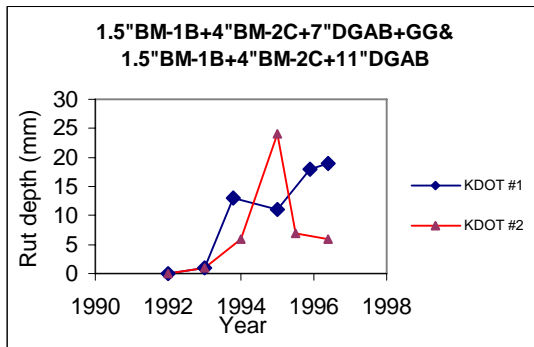
Figure 9. Rutting on section KDOT #1 & #2

For section KDOT #1 (1.5-in. BM-1B/4-in. BM-2C/7-in. DGAB), the subgrade modulus at the OWP (5,330 psi) was somewhat lower than that at the MLP location (6,750 psi). The effective pavement modulus at the OWP location (43,740 psi) was more than 50% lower than that at the MLP location (78,230 psi). Thus, the effective structural number ( $SN_{eff}$ ) at the OWP location was much lower than that at the MLP location (1.98 vs. 2.41). On section KDOT #2 (1.5-in. BM-1B/4-in. BM-2C/11-in. DGAB), the backcalculated subgrade moduli at both locations were comparable (6,960 psi and 7,100 psi). The effective pavement moduli (93,170 psi and 87,100 psi) were also comparable, as were the effective structural numbers (3.37 vs. 3.29). It is to be noted that the geogrid in section KDOT #1 (1.5-in. BM-1B/4-in. BM-2C/7-in. DGAB/GG) was assumed to be equivalent to 4 inches of DGAB in the original design. The distress survey and FWD test results do not appear to support this assumption.

Gradation tests were run on the DGAB materials for sections KDOT #1 (1.5-in. BM-1B/4-in. BM-2C/7-in. DGAB) and KDOT #2 (1.5-in. BM-1B/4-in. BM-2C/11-in. DGAB). The results showed that the materials have similar gradations and that they fall well within the required DGAB specifications. However, material passing the No. 200 sieve lies near the maximum percent passing of the grading band.

On both KDOT #1 and KDOT #2, the tensile strength ratios (TSR) determined from the modified Lottman tests on the cores were initially found to be very low for the BM-2C mixes (42% for KDOT #1 and 30% for KDOT #2). The cores were then reheated and recompact to densities comparable to the core densities and the tests were rerun. For the recompact BM-2C mixes, the TSR was 57% corresponding to 57% saturation, which was lower the required minimum value. The TSR for BM-1B was 78.9%, which is slightly lower than the minimum 80% required for the Superpave mixes. Therefore the surface mix BM-1B indicated non-susceptibility to stripping, while the base mix BM-2C might be susceptible to stripping.

From the FWD analysis, it was determined that section KDOT #1 (1.5-in. BM-1B/4-in. BM-2C/7-in. DGAB/GG) would require an additional 6 inches of hot mix asphalt overlay to support the traffic (2,962,000 ESALs) for the next ten years and section KDOT #2 (1.5-in. BM-1B/4-in. BM-2C/11-in. DGAB) would require an additional 2 inches for the same time period.

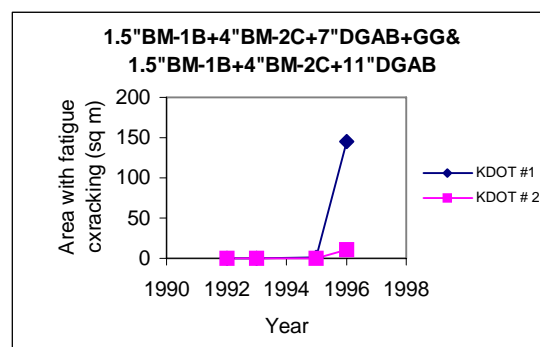
Figure 10. Fatigue cracking on section KDOT #1 & #2

Sections KDOT #1 (1.5-in. BM-1B/4-in. BM-2C/7-in. DGAB/GG) and KDOT #2 (1.5-in. BM-1B/4-in. BM-2C/11-in. DGAB) were observed to have major cracking problems. The DGAB fines appeared through the cracks in the ruts. These sections had indicated rutting failure and cracking. Laboratory testing on the cores showed that the rutting in section KDOT #1 (1.5-in. BM-1B/4-in. BM-2C/7-in. DGAB/GG) was due to unstable surface and base layers. KDOT #1 and KDOT #2 were milled up to four inches and inlaid with a BM-2 mix in 1997. A three-inch BM-2 overlay was then placed on both sections.
