CHAPTER 11: LIGHTING (VEHICLE CONSPICUITY)

Conduct proof of concept regarding use of high-intensity lighting systems to improve snowplow visibility.

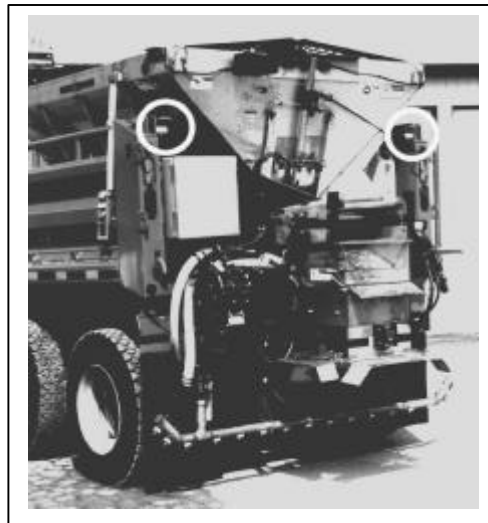
Figure 11-1 Fiber optic light system (circled), Iowa prototype vehicle

Iowa DOT mechanics encountered challenges with Innovative Warning Systems' High Intensity Discharge (HID) Fiber Optic Lighting System. It was installed by Iowa DOT personnel. The light engine in the prototype vehicle's cab was the first component to cause challenges. It seemed very sensitive to mounting orientation, mounting location, and the routing of the fiber-optic cables.

According to Iowa DOT mechanics, most of the challenges with the HID lighting system stemmed from the system's fiber-optic cables. The most troublesome challenge involved the intrusion of moisture into the cables' lining, causing the light to reflect along the cable improperly, or not at all. The moisture entered between the cable's inner lining and the fiber optic strands. Through experimentation, Iowa DOT mechanics discovered an improvement in light transmission when they cut the fiber-optic cables to make them shorter. There is a limit to the extent that the fiber optic cables may be shortened, namely a length long enough to permit continued operation, free movement, and deployment of the prototype truck's components when the lighting system is still in use.

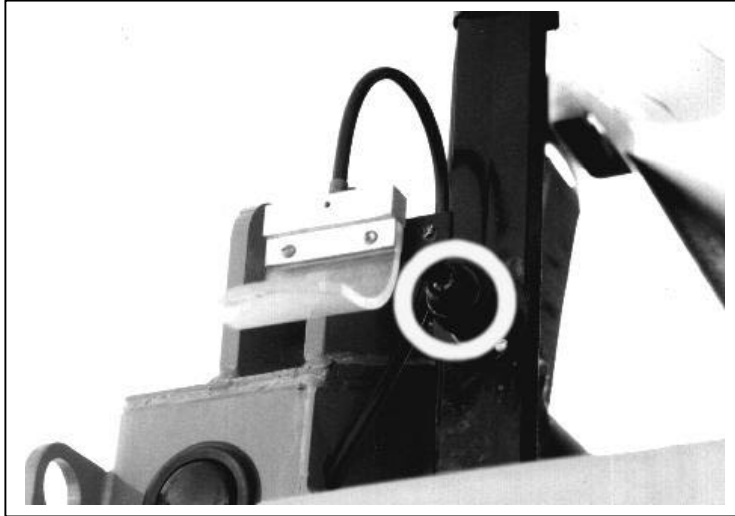
Figure 11-2 Left ball-and-socket joint (circled), HID lighting system, Iowa vehicle

To solve the two rear HID light challenges involving (1) moisture intrusion and (2) precise aim and positioning required with the HID lights, Iowa DOT mechanics mounted the rear HID light upside down (to eliminate the water intrusion) and onto a ball and socket joint to provide proper positioning. This ball and socket joint enabled Iowa DOT mechanics to easily tilt and aim the rear HID light up, down, left, and right. The ball and socket joint was originally conceived by the Minnesota DOT on their prototype vehicle. See Figures 11-2 and 11-3 for pictures of these ball-and-socket jointed lights.

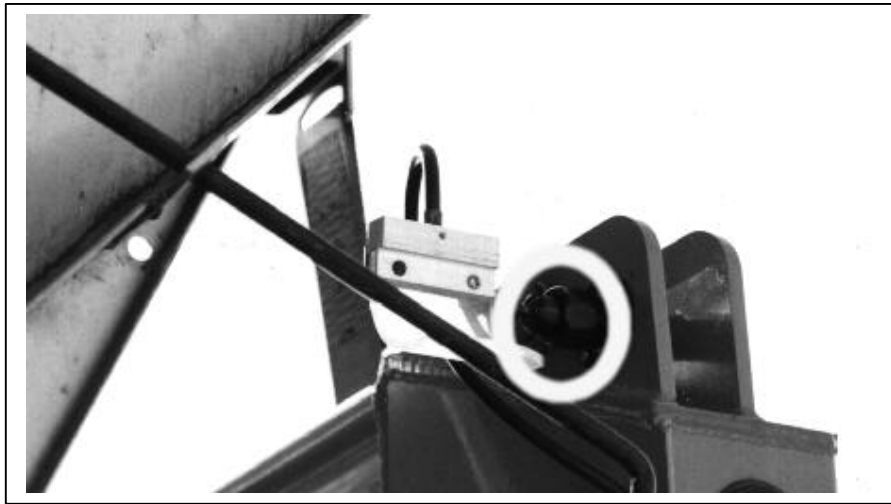
Figure 11-3 Right ball-and-socket joint (circled), HID lighting system, Iowa vehicle
