Evaluation of Steel Girder Bridges Strengthened with FRP

Yoon-Si Lee
Bridge Engineering Center – CTRE
Iowa State University
2901 South Loop Dr., Suite 3100
Ames, IA 50010,
(515) 294-5642 (ph)
(515) 294-0467 (fax)
lys@iastate.edu

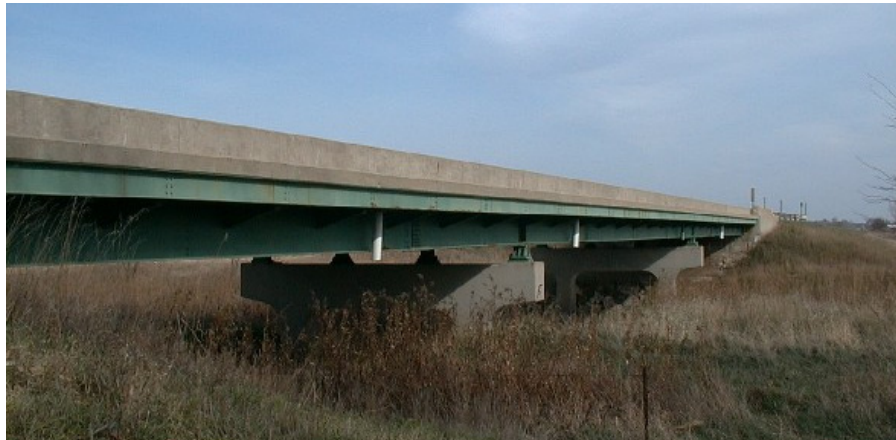
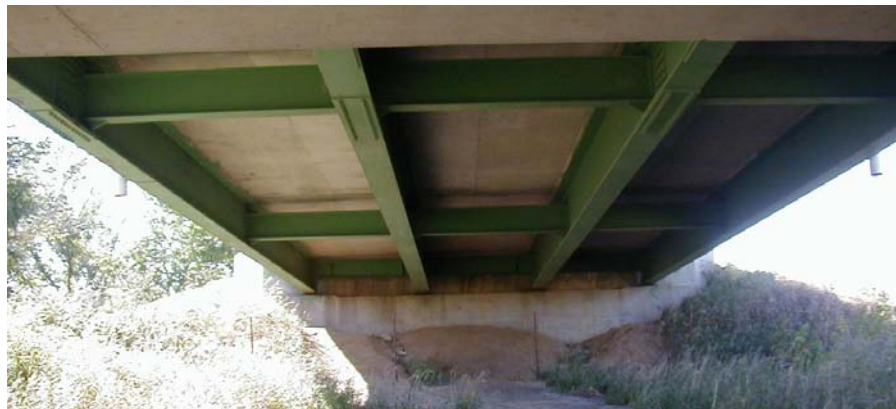
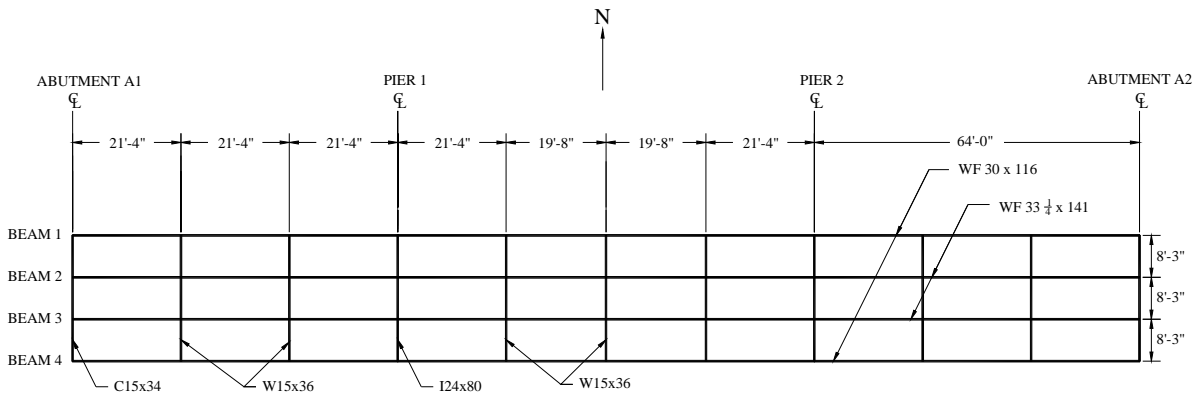
FIGURE 1 Photographs and framing plan of Bridge 1.

Bridge 1 (number 3903.OS 141) which was strengthened with post-tensioning (P-T) CFRP bars is a 210 ft x 26 ft, three-span continuous, rolled shape steel girder bridge constructed in 1956 (shown in Fig. 1). It is located in southwest-central Iowa approximately 1.6 miles west of Bayard, Iowa carrying State Highway IA 141 over Willow creek. The bridge consists of two 64 ft end spans and a 82-ft center span with four beams spaced at 8'-3" on center. The bridge beams are spliced at locations 20 ft from the two piers in all spans (i.e., four splices per beam line). The bridge deck is a nominal 7-in. thick cast-in-place, reinforced concrete slab that was overlaid with dense low-slump portland cement concrete (PCC) in 1987. The current average deck thickness is approximately 10 in., including 3 in. of wearing surface with 2 1/2 in. of crown. The bridge deck is supported by two WF 30x116 exterior and two WF 33 1/4x141 interior I-beams.

(a) Side view

(b) Bottom view

(c) Framing plan

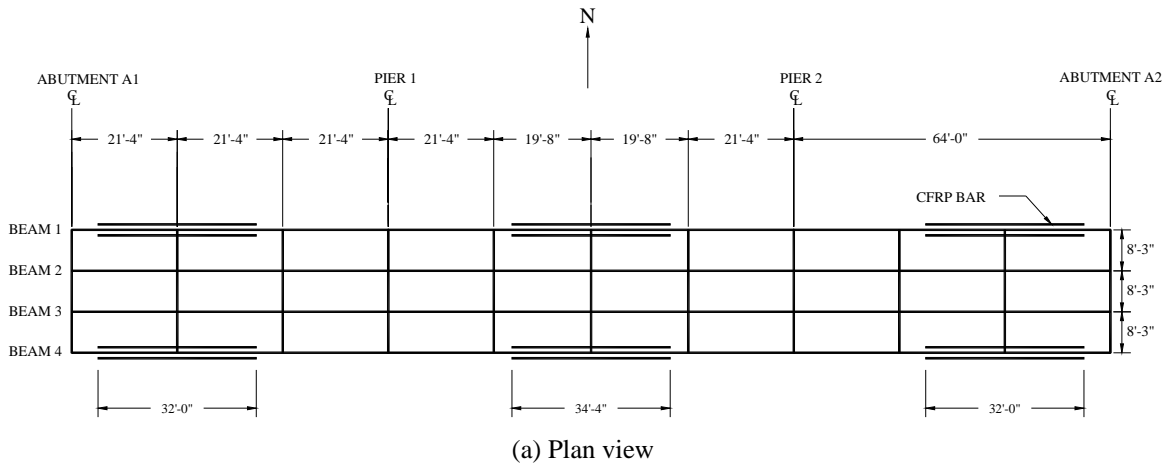
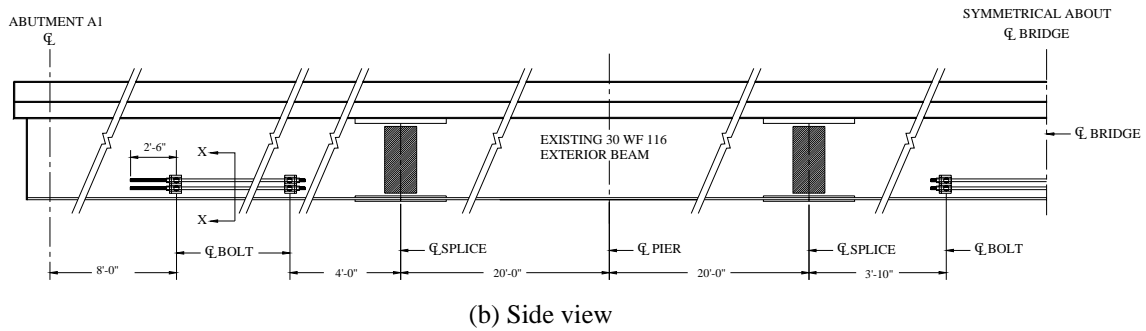
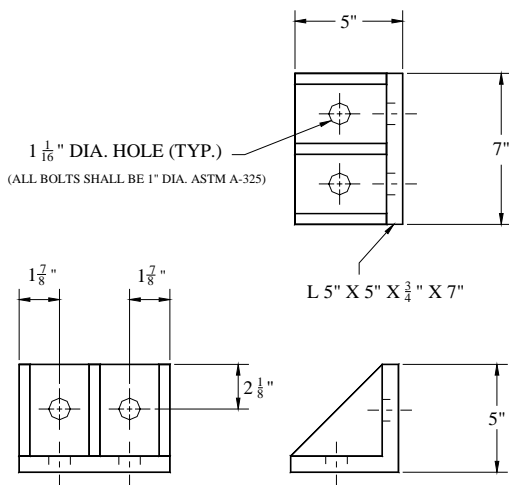
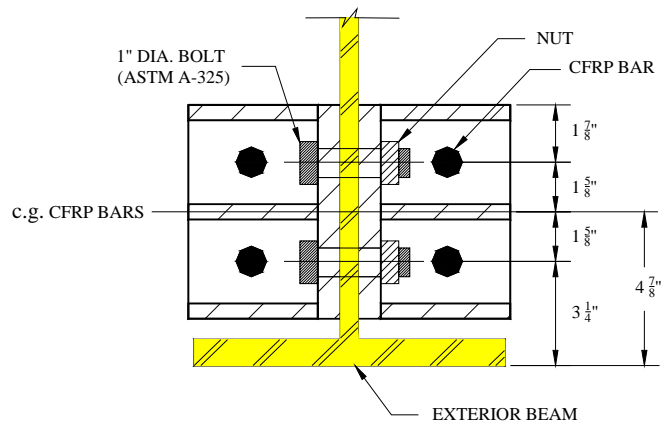
FIGURE 2 Location of the P-T system and anchorage assembly details on Bridge 1.

The P-T based strengthening system utilized was developed based on the strengthening recommendations of Klaiber et al [2] and material performance data provided by the manufacturer. The design of the CFRP P-T strengthening system was completed for the HS-20 load [3] utilizing the Allowable Stress Design (ASD) approach. Based on analysis completed by the bridge owner, it was found that the positive moment region of the exterior beams in both the end and center spans were overstressed.

The CFRP bars used in this project are 3/8 in. in diameter and have a high tensile strength (300 ksi), a moderate modulus of elasticity (20,000 ksi), low creep properties, and a high resistance to corrosion. For connection to the other P-T system components, the CFRP bars are embedded into steel tube anchors that have threaded ends. The CFRP bars, via the steel tubes, were connected to the steel beams with 5 in. x 5 in. x 3/4 in. stiffened angles 7 in. in length. Each of these stiffened angle assemblies, which are connected to the web of the steel beams with two 1 in. diameter A325 high-strength bolts, connects four CFRP bars to the web of the beam (two on each side) near the top surface of the bottom flange. The installation of the P-T system was completed in the positive moment region of the exterior girders in all three spans. The location of the P-T system and anchorage assembly details are shown in Fig. 2. A total of 12 kips was applied to each bar (four bars, 48 kips, per location). A list and brief description of the principal installation steps follow:

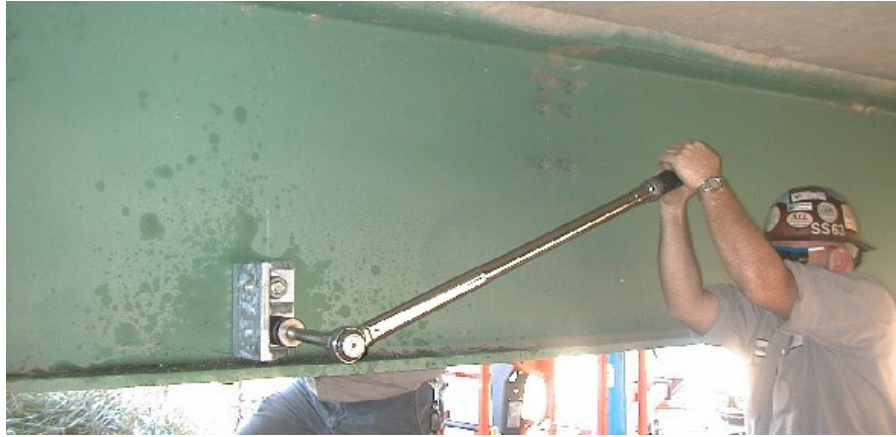
(a) Installation of anchorage assembly

FIGURE 3 Photographs of installation, P-T force application and completed installation on Bridge 1.

The photographs of the installation, application of P-T force and completed installation are shown in Fig. 3.

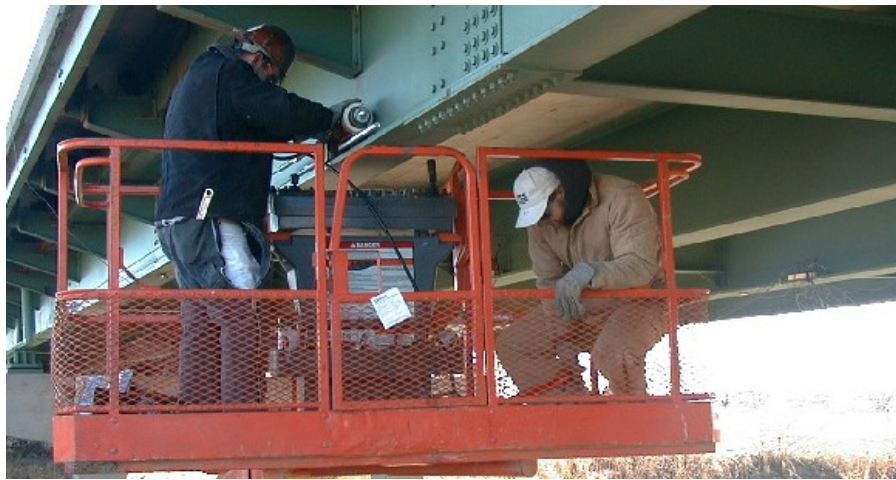
(b) Application of P-T force in the center span

7. A nominal force of 12 kips was applied to all bars (four bars, 48 kips, per location) with a hollow-core hydraulic jack in a symmetrical manner following the sequence of steps listed below, where each event defines a specific step in the P-T process:

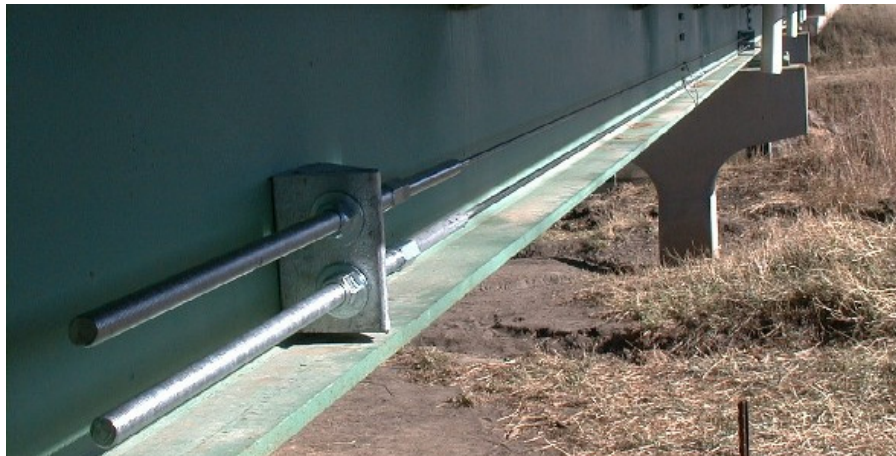
(c) Completed installation of exterior CFRP bars in west end span

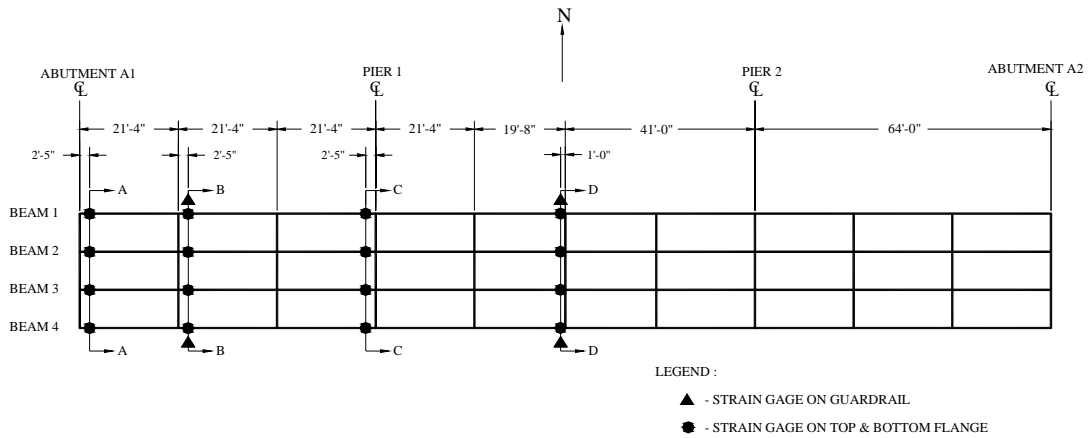
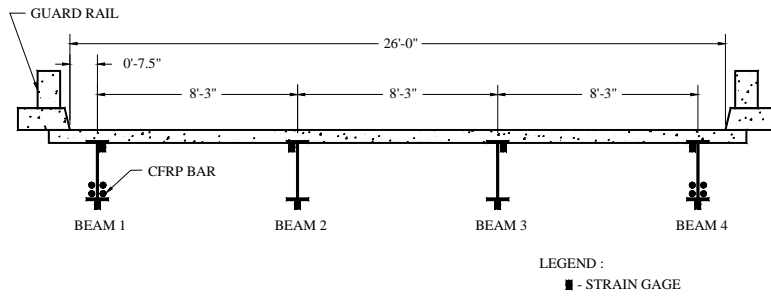
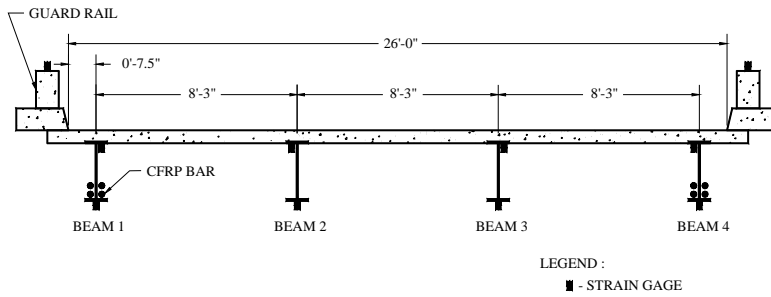
FIGURE 4 Instrumentation and load paths used for testing on Bridge 1.

The bridge was tested four times: before, shortly following the installation of the strengthening system, and after one and two years of service. The location of the instrumentation was selected so that the live load response of the bridge could be determined to provide an overall understanding of the global behavior. A total of thirty-six strain gages were installed on the bridge with thirty-two gages on the top and bottom flanges of the beams and four gages on the guardrails. Due to the structural symmetry of the bridge, only one-half of the bridge was instrumented.

(a) Strain gage locations

(b) Sections A and C

(c) Sections B and D

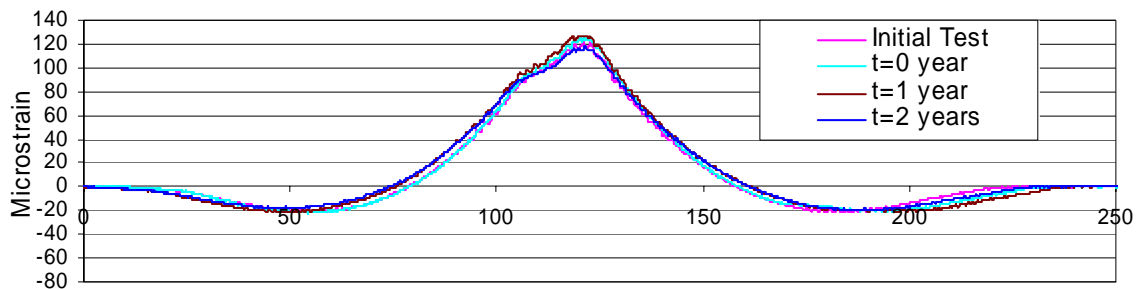
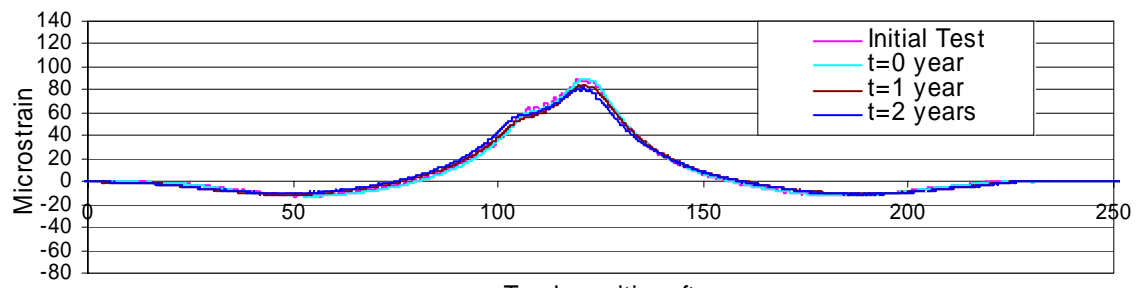
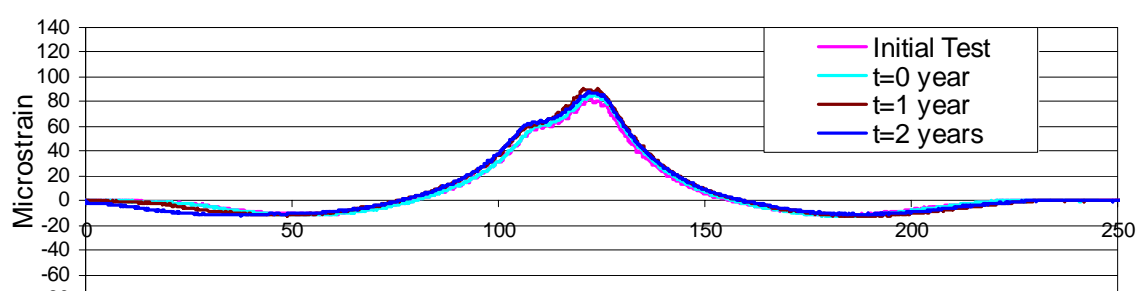
FIGURE 5 Bottom flange strain data in center span, Beam1 of Bridge 1.

Each subsequent load test produced fairly consistent strain readings with those established during the initial test (see Fig. 5 for typical examples). This consistency in strain is informative in that it indicates that the P-T system did not significantly alter the behavior of the bridge over the two years of service, as would be expected. Although it is not possible to precisely account for all the sources of strain, it is evident from the consistency of the strain data that the installation of the P-T system had negligible impact on changing the stiffness of the bridge. The data also indicate that the live load distribution characteristics are virtually the same before and after the installation of the P-T system.

(a) Beam 1 (Path Y2)

(b) Beam 2 (Path Y1)

(c) Beam 3 (Path Y3)

- The addition of the P-T strengthening system had a negligible impact on the stiffness of the bridge. This resulted in the live load distribution characteristics remaining virtually the same before and after the installation of the P-T strengthening system.

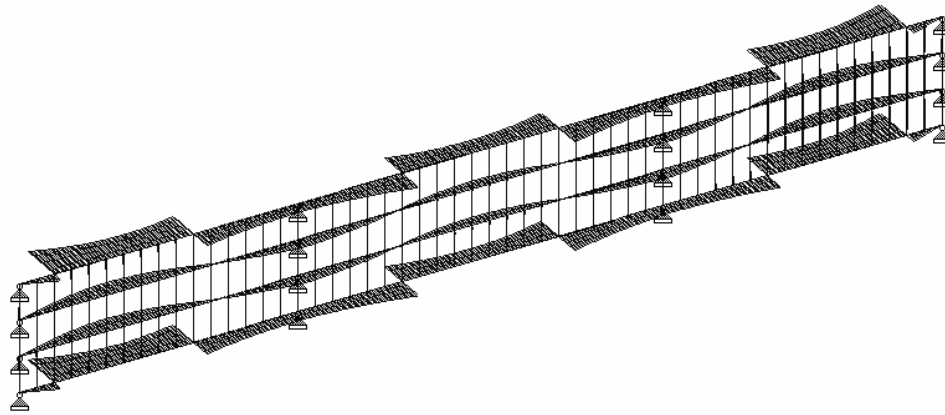
The P-T force generates moments opposite in sign to those induced by the dead load at both the maximum positive moment region (midspan) and maximum negative moment region (pier). Three point loads were used to represent the HS-20 truck [3]. The codified [3] lateral distribution factors for the exterior and the interior girders were applied to the total live load induced moments. The experimental lateral distribution factors obtained during the application of the P-T force were used in computing the P-T induced moment [4]. In order to investigate an overall effect of the P-T strengthening system on the bridge, the P-T induced moment, dead load moment and live load moment were added together as is illustrated in Fig. 6b. Note that the moment diagrams presented are not to scale.

(a) Theoretical P-T induced internal moments.

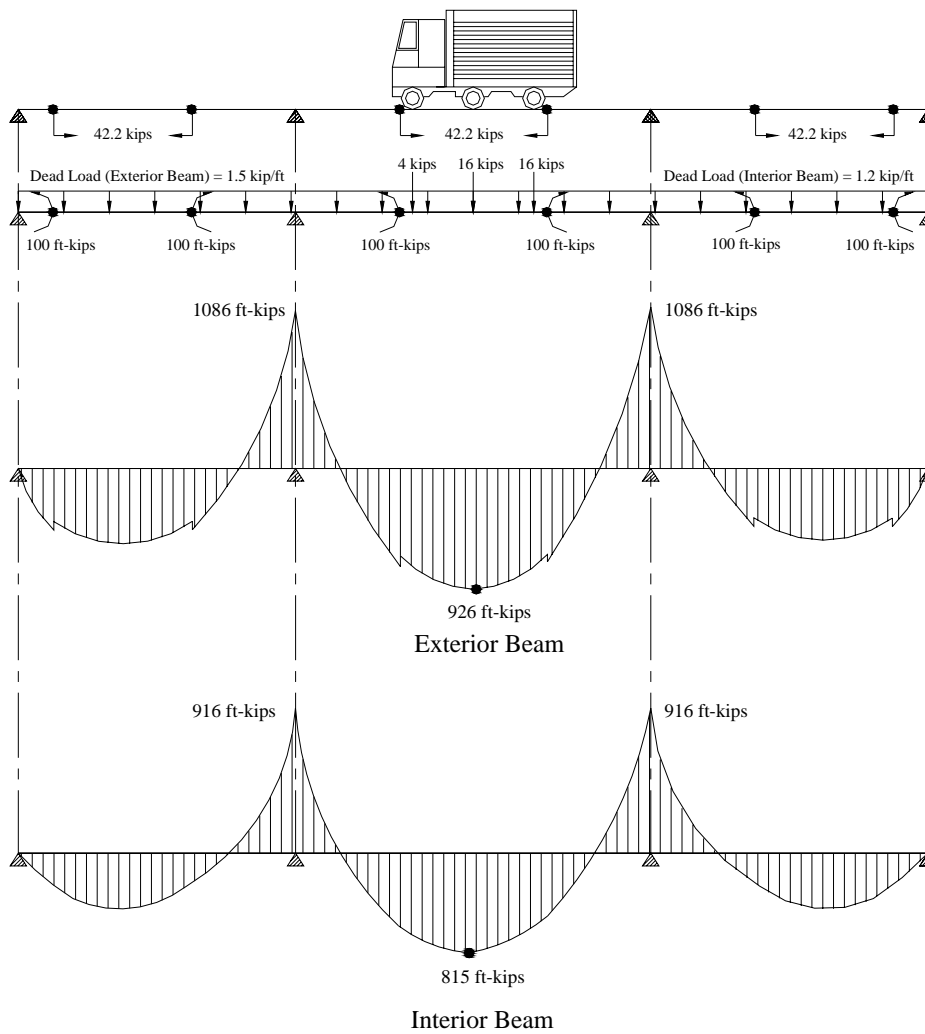
As expected, the exterior girder experienced a larger reduction in total moment than the interior girder in both the end and the center spans. In general, the end spans showed larger moment reductions than the center span. The P-T strengthening system reduced the total moment by 5.3% on the exterior beam and 4.6% on the interior beam in the end span. Similarly, 3.3% and 2.7% of the total moment was reduced on the exterior and the interior beam in the center span, respectively [4].

(b) Effect of P-T on maximum moments in the center span.

FIGURE 6 Theoretical P-T induced internal moments and Effect of P-T on maximum moments in Bridge 1.

- The P-T system generates strain opposite to those produced by gravity loads and thereby improves the overall live load carrying capacity of the bridge. Based upon an analysis performed utilizing the HS-20 truck, it was found that the P-T strengthening system reduced the dead and live load induced moments by approximately 3 to 5%, thus allowing the bridge to carry additional live load.

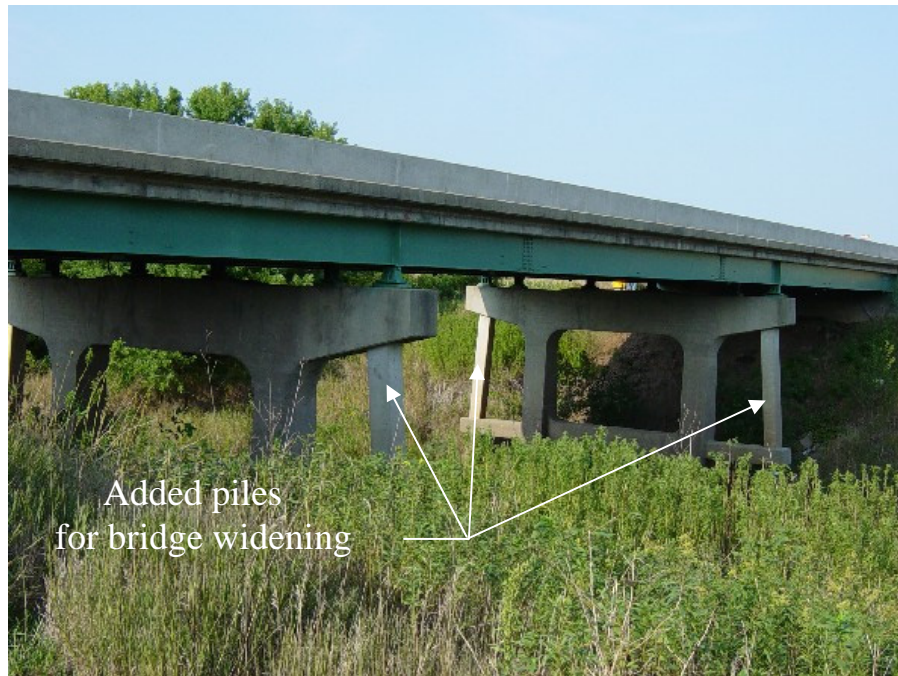
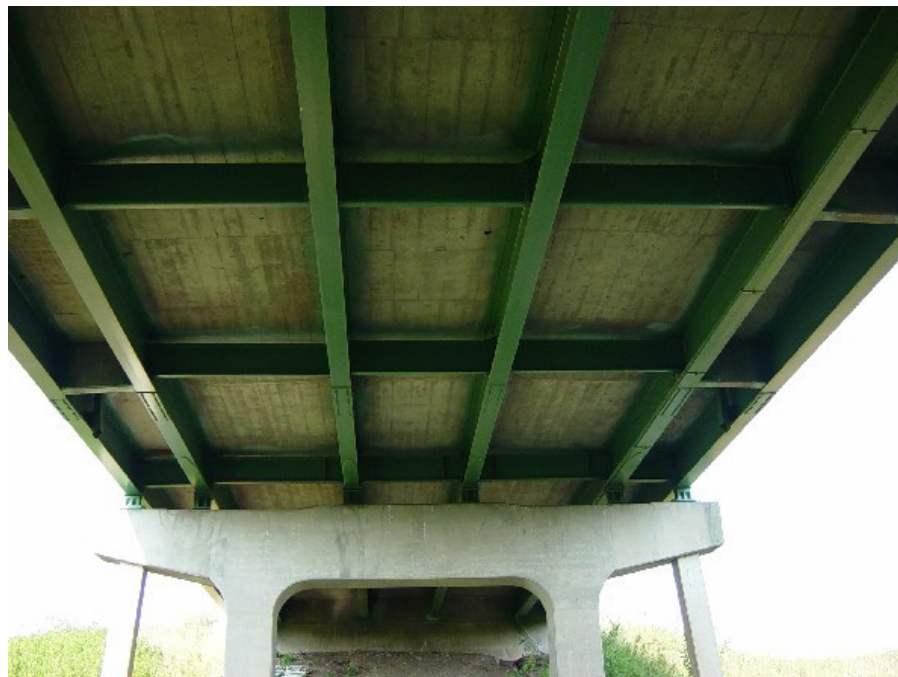
FIGURE 7 Photographs of Bridge 2.

Bridge 2 (number 7838.5S092) strengthened with CFRP plates is a 150 ft x 30 ft three-span continuous I-beam bridge in Pottawattamie County, Iowa, on State Highway 92 (shown in Fig. 7). Originally the bridge was a non-

composite structure. In 1967, the bridge was widened with the addition of exterior girders that were made composite with the deck. The bridge has a total length of 150 ft consisting of two end spans of 45.5 ft and a center span of 59 ft and is supported by six beams: two W27x84 exterior I-beams installed in 1967, two W27 x91, and two W27x98 interior I-beams. The roadway width is 30 ft allowing two traffic lanes and a shoulder on each side.

(a) Side view

(b) Bottom view

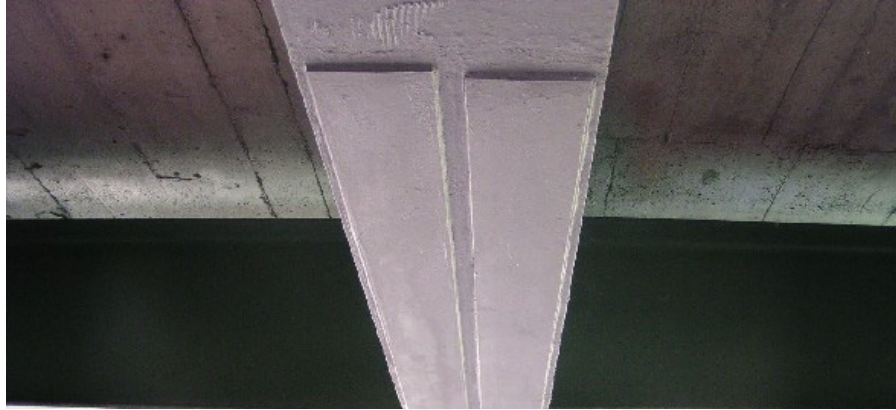
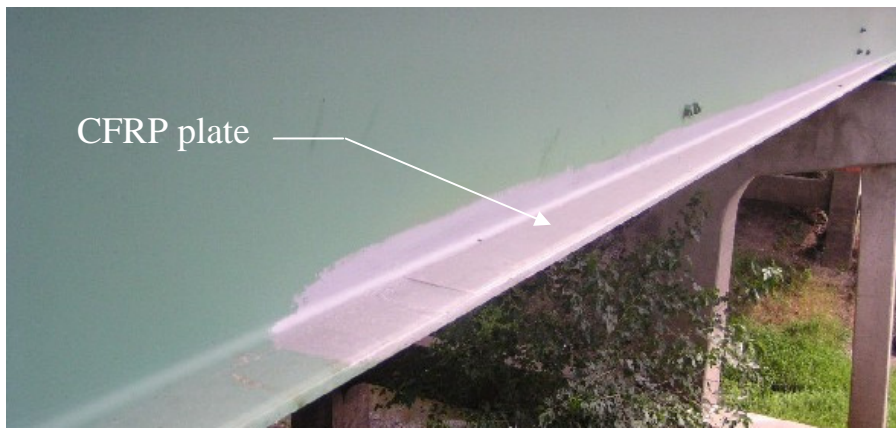
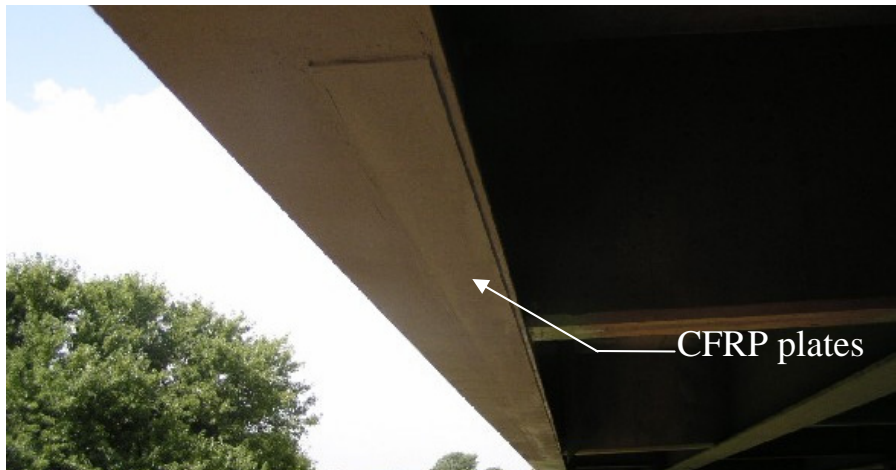
FIGURE 9 Photographs of installed CFRP strengthening system on Bridge 2.

Temporary scaffolding was constructed underneath the bridge in both end spans to provide easy access to the beams for installing the strengthening system. Access to the center span was provided through the use of a “snooper” truck. The steel beam surfaces to which the CFRP plates were to be bonded were roughened to a coarse sandpaper texture by sandblasting to remove any lead free paint and unsound material. After sandblasting, the beam surface was cleaned with acetone. The bonding surfaces of the CFRP plates were also cleaned at that time with acetone. After the bonding surfaces were dry, the prepared beam surface was treated with a thin layer of FRS Primer to prevent corrosion induced by a galvanic reaction between the beam surface and carbon fibers. Once the primer had set, ECS 104 structural epoxy was applied to both the pre-cut CFRP plates and the beam surface using a 1/8 in. v-notched trowel. The plate was then carefully placed on the beam surface, starting at one end, taking special care to ensure a “straight” application. A smooth, hand roller was then used to apply pressure to the plate to evenly distribute the epoxy and to remove any trapped air. A smooth trowel was then used to remove any excess epoxy from the edges of the CFRP plates. After all plates were installed and the epoxy had cured, all surfaces were painted. Photographs of the completed installation are presented in Fig. 9.

(a) Beam 4 in the east end span

(b) Top of bottom flange of Beam 6 in the west end span

(c) Bottom of bottom flange of Beam 6 in the east end span

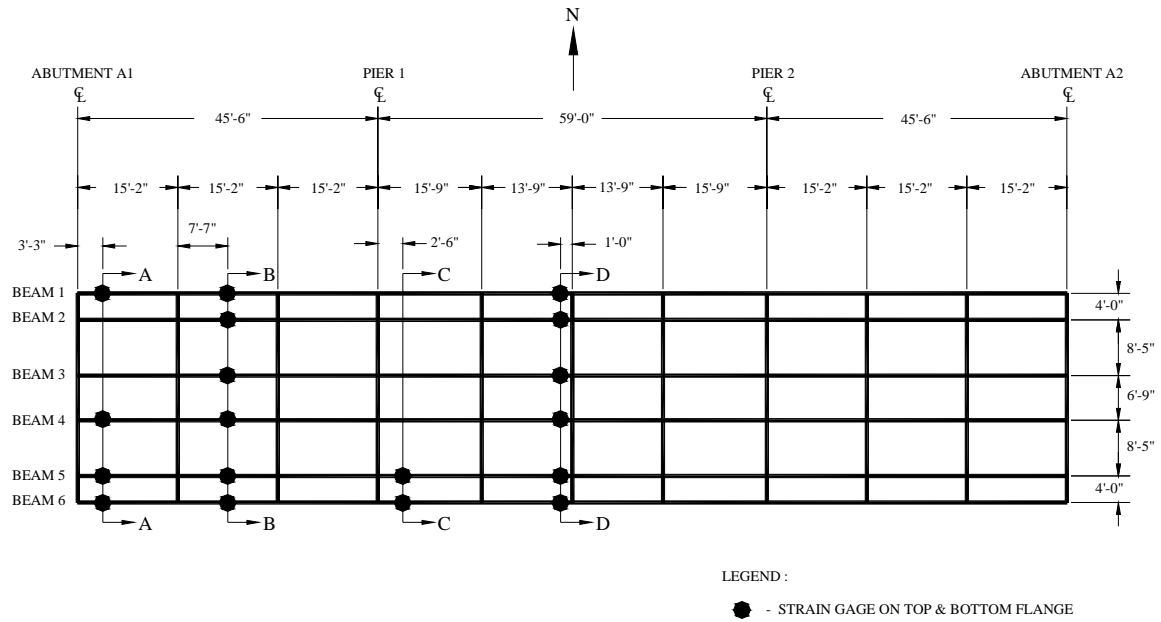
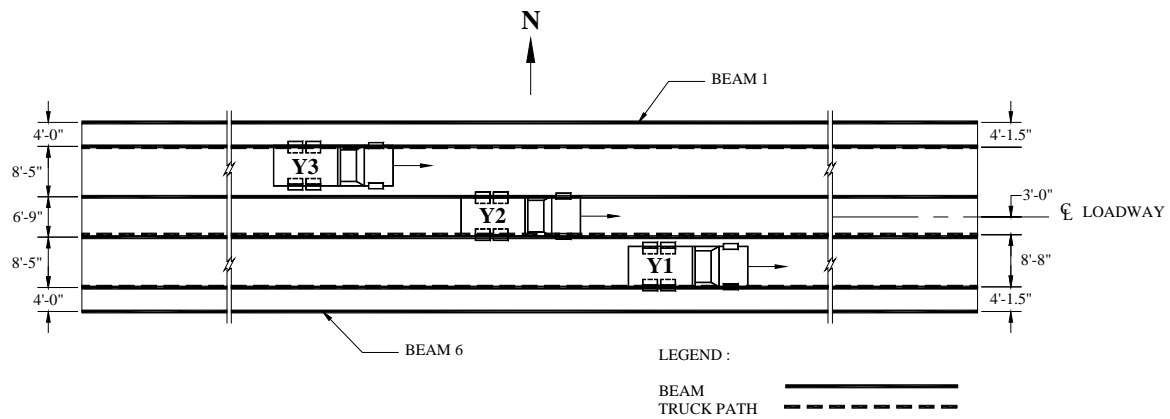
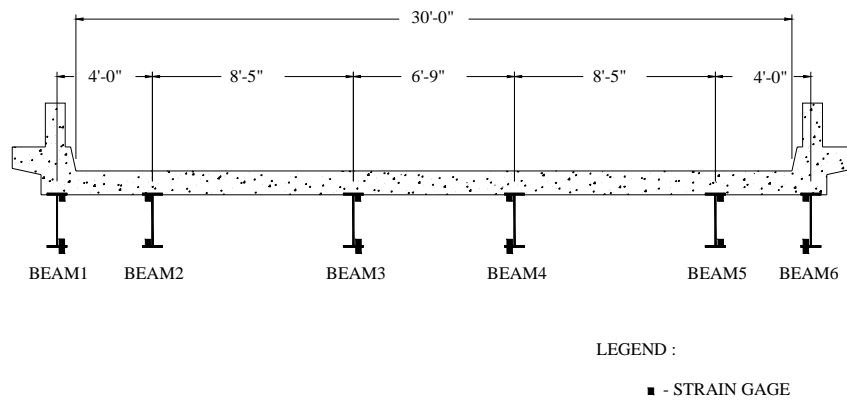
FIGURE 10 Instrumentation layout and truck paths used for testing on Bridge 2.

An initial diagnostic load test was conducted prior to the installation of the CFRP plate strengthening system to establish a baseline static behavior of the unstrengthened bridge. The location of the instrumentation was selected to effectively monitor the overall global response of the bridge to live load. As can be seen in Fig. 10a, a total of thirty-six strain gages were installed on the bridge with twenty-four gages on the positive bending moment regions and twelve gages on the negative bending moment regions. Three different truck paths were used to examine the performance of the bridge. These truck paths were chosen so that maximum strains could be generated in selected girders. For convenience, load paths are referred to as Y1, Y2 or Y3 as shown in Fig. 10b. All tests were conducted from west to east.

(a) Instrumentation layout

(b) Truck paths

(c) Cross-section (Section D)

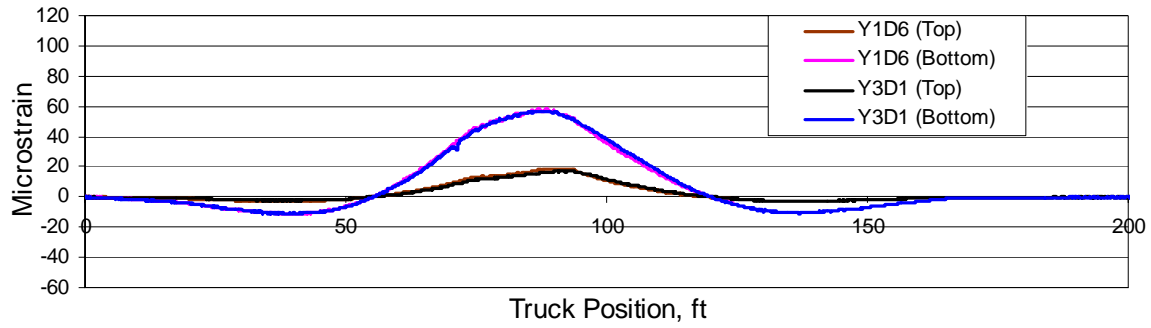
As shown in Fig. 11a, the measured strains indicate good lateral symmetry that corresponds to the symmetrical configuration of the bridge and the truck paths used. Some of the minor differences in transverse symmetry may be attributed to either difference in local stiffness, difference in rotational end restraint at the abutment, or possible experimental error that might have occurred during the testing (e.g., differences in truck wheel line distribution and/or truck lateral positioning).

(a) Lateral symmetry: strain in Beam 6 (Path Y1) and Beam 1 (Path Y3)

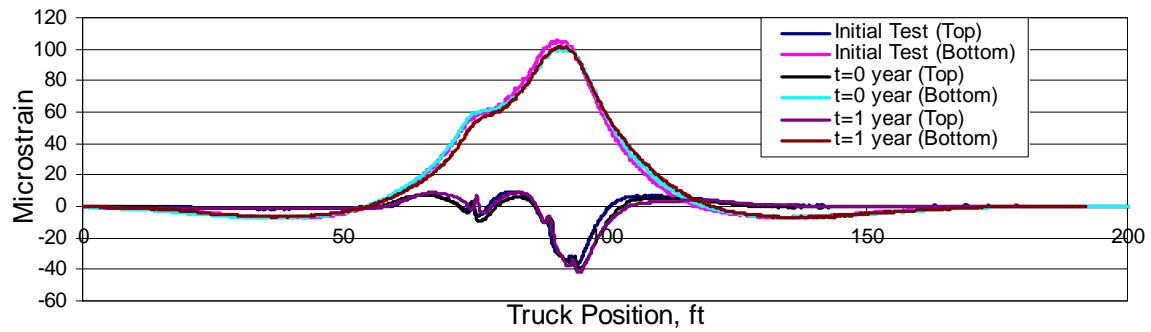
From the analysis discussed earlier, it was determined that an approximate stiffness increase of 1.2% per layer was obtained for the middle two beams. By comparing strains in each test, it was observed that the follow-up tests did produce fairly consistent strains with those measured during the initial test. This consistency in strain indicates that the strengthening system did not significantly alter the behavior of the bridge as predicted. Although it is not possible to precisely account for all the sources of strain, it is evident from the consistency of the strain data that the installation of the CFRP plates had little impact on changing the stiffness of the bridge. It also indicates that the live load distribution characteristics are virtually the same before and after the installation of the strengthening system. A typical comparison between the pre- and post-strengthening response is shown in Fig. 11b.

(b) Similarity in response before and after strengthening: strain in Beams 3 (Path Y2).

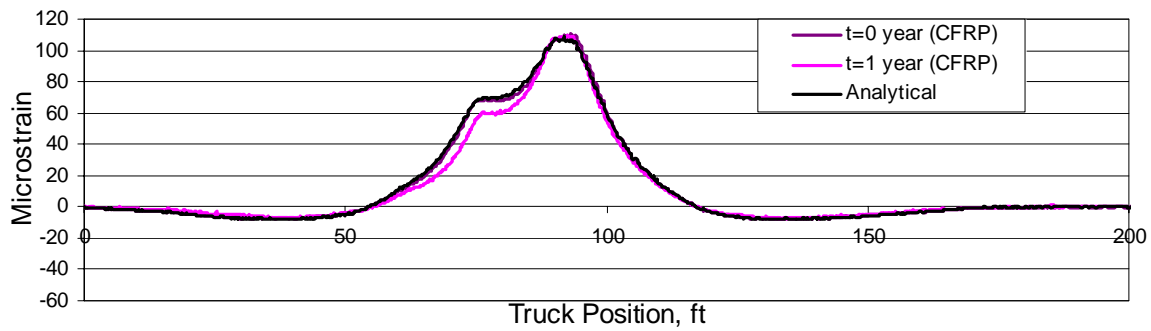
From the comparison, it was found that the difference between the analytical and experimental strain was only 3.8% on average. The similarity between the analytical and experimental strain is shown in Fig. 11c. Considering the sensitivity of the neutral axis location that could change significantly with a small change in strain,

this percentage error is considered to be relatively small; thus, it appears that there was good bond between the beam and CFRP plates.

(c) Strain in Beam 4 CFRP plate
