Monitoring and Evaluation of a Plate Girder Bridge

Terry J. Wipf, Brent M. Phares, Lowell F. Greimann, Douglas Wood

Iowa State University

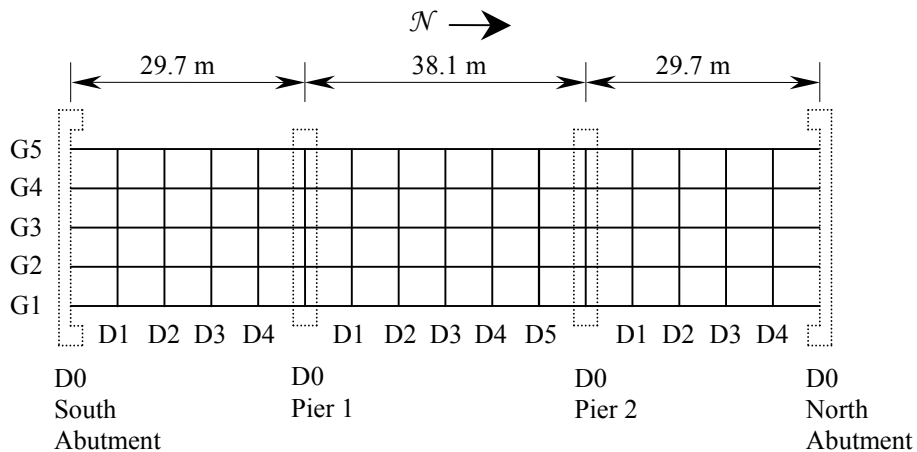
FIGURE 2. Plan View Illustration of Superstructure

Bridge 4048.2S017, shown in Fig. 1, is a three span bridge crossing the Boone River on Highway 17 in central Iowa. As shown in Fig. 2, the end spans are 29.7 m and the interior span is 38.1 m. The girders are labeled as G1 to G5 and the diaphragms in each span are labeled as D0 to D5. The bridge has five main plate girders with an integral concrete deck as shown in Fig. 3. The 1.5 m deep girders are connected by X-type diaphragms every 6.1 m. A visual inspection revealed no fatigue cracking in the girder webs near the connections to the diaphragms. However, many multiple steel girder bridges with this diaphragm connection detail in Iowa have experienced cracking in that region.

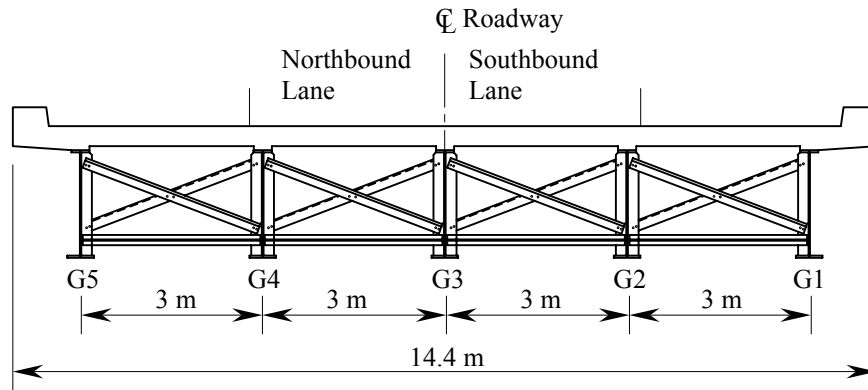
FIGURE 3. Illustration of Bridge Cross Section at Negative Moment Diaphragm

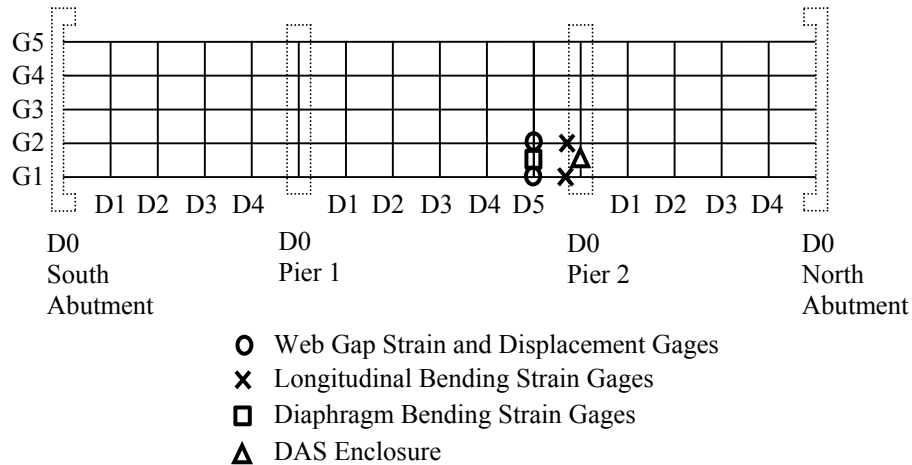
FIGURE 6. Illustration of Instrumentation Locations on the Superstructure

A Campbell Scientific CR 9000 was selected as the base for the remote continuous monitoring data collection system. The system was set up in an environmental enclosure on Pier 2, which provided the system protection from the weather and vandalism as shown in Fig. 5. The system has an input capacity of 24 channels with further expansion possible. Thermocouples, strain gages, and displacement transducers were used in this study, but the system is capable of supporting many different sensor types. Instrumentation was focused at a diaphragm in the negative moment region near Pier 2 as illustrated in Fig. 6.

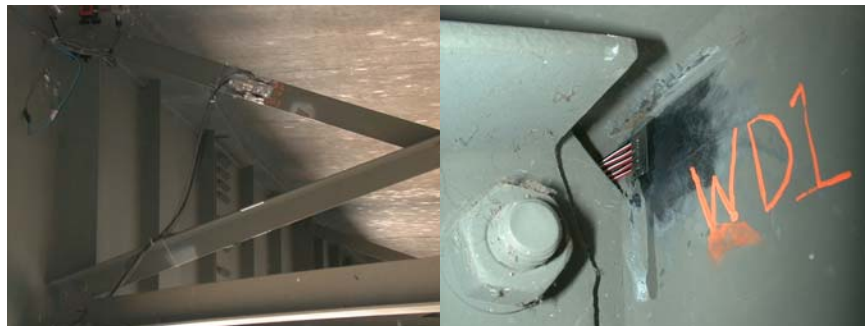
FIGURE 7. Photographs of Diaphragm and Web Gap Strain Gages

Two gradient strain gages were installed in the G1 and G2 web gaps as shown in Fig. 7. These gradient gages consist of five small, foil backed strain gages placed within the web gap to collect a detailed strain profile. For this study the strain in the web gap was the most important indicator of the effectiveness of the retrofit.

Three weldable strain gages were mounted on the diaphragm members between G1 and G2 as pictured in Fig. 7. The gages were encased in plastic to provide protection from the environment.
