Simple Design Alternatives to Improve Drainage and Reduce Erosion at Bridge Abutments

ABSTRACT

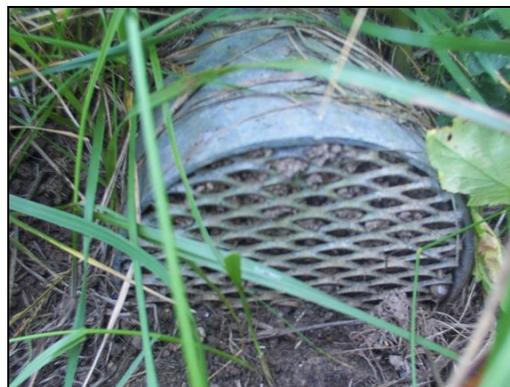
Figure 2. Example of a blocked subdrain outlet (Bridge No. 9266.2R218, District 5)

At all bridge sites investigated, visual observations were made as to the conditions of the subdrain tile. The inspections showed that many subdrains were completely dry, partially collapsed, or plugged with soil and debris (see Figure 2). In addition to visual observations, the subdrains of six bridge sites were inspected using a special Iowa DOT forensic camera (“snake” camera) that is inserted through the subdrain outlet using a special cable and camera head. The inspections using this procedure confirmed earlier visual inspections of collapsed and plugged subdrains.

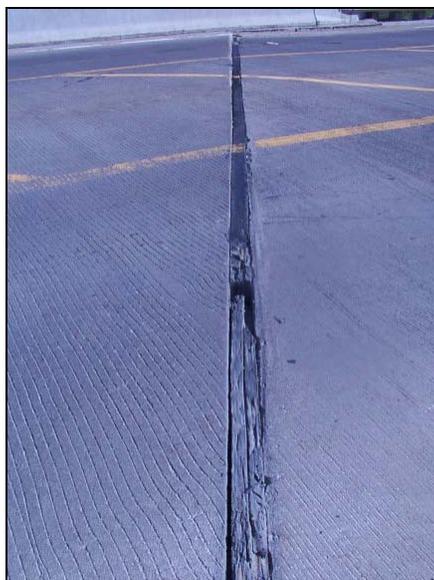
**(a) Deteriorated joint filler
(Bridge No. 2034.20035, District 5)**

Figure 3. Typical unsealed expansion joints

Unsealed expansion joints inhibit proper surface drainage by allowing water infiltration through the joint and down into the bridge approach backfill (see Figure 3). The majority of expansion joints observed were not sealed sufficiently to prevent water infiltration. Iowa DOT uses flexible foam filler, which is a common joint filler type, but recently, recycled tire chips are increasingly being used over flexible foam. Both types of joint filler however do not completely seal the expansion joint. Currently, Iowa DOT practices do not intend for the expansion joints to be sealed. This is primarily due to a lack of identifying a suitable joint sealing system capable of withstanding the harsh environmental conditions in Iowa.

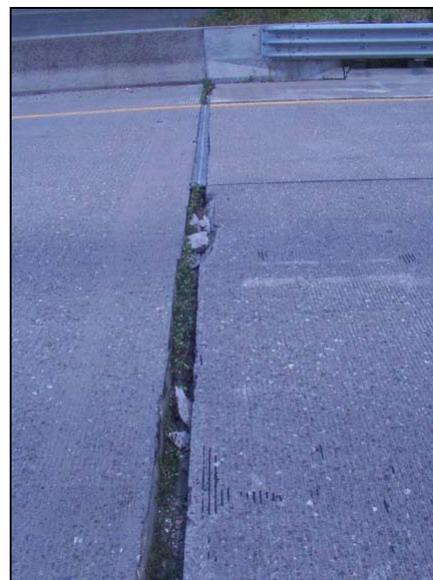
**(b) Missing joint filler
(Bridge No. 9265.7L218, District 5)**

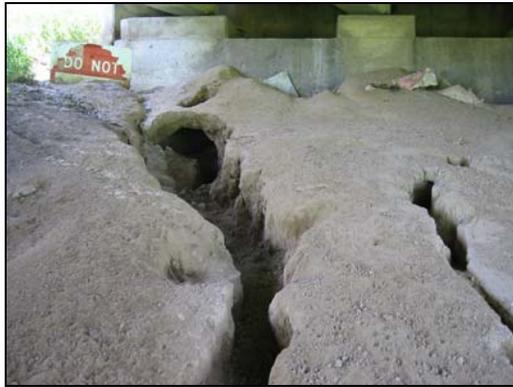
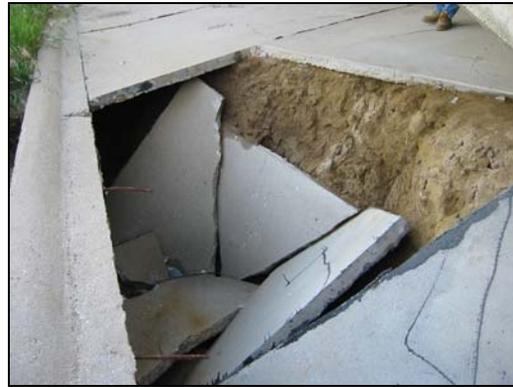
(a) Bridge No. 9703.40020, District 3

(b) Bridge No. 7871.5L/R029, District 4

Figure 4. Erosion (a) at an embankment under the bridge and (b) under a slope protection

Erosion of soil under the approach slab, at the shoulders, at the embankment under the bridge, and along the abutment sides are all forms of erosion observed during field inspections (see Figure 4). If not mitigated, soil erosion can lead to other problems, such as exposure of steel H-piles, undermining of abutment, faulting of pavement, or failure of the slope protection cover under the bridge.

Besides the inability to redirect surface runoff, soil erosion under approach slabs is also attributed to the use of erodible backfill materials. Briaud et al. (1997) provided a range of most erodible soils and reported that soils with silt and fine sand are more erodible than other types. The erodible range of soils was compared to the Iowa DOT gradation requirement for granular backfill and the grain-size distribution obtained for four different granular backfill samples collected at new bridge sites. It was found that the Iowa DOT gradation requirement and the gradations from the field samples have a common region with the range of most erodible soils. This is primarily attributed to the wide range allowed to pass the No. 8

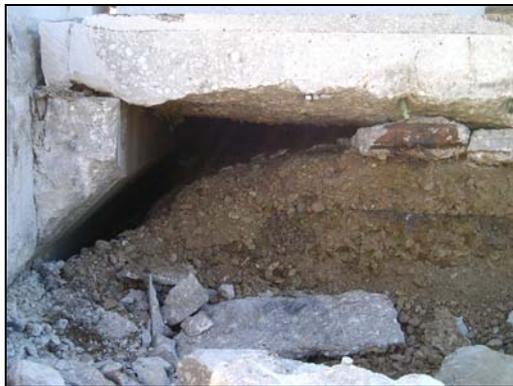
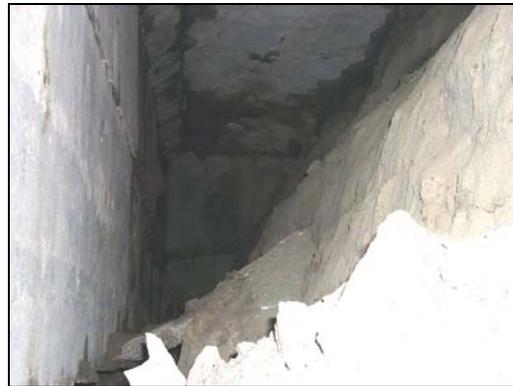
(a) Bridge No. 7779.0065, District 1

(b) Bridge No. 9703.40020, District 3

Figure 5. Void formation under the approach slab

Wetting-induced soil collapse is another important factor that increases the likelihood of soil erosion. Upon saturation, granular soil can collapse creating a void and, thus, a water path, which facilitates additional soil erosion and progressive approach slab settlement (see Figure 5). Laboratory testing was conducted to measure the Collapse Index (CI), which is the change in the sample height upon saturation relative to its original height, for the granular and porous backfill materials used behind bridge abutments in Iowa. The highest CI measured for granular material was 6% when placed at the bulking moisture content range (3% to 7%), while porous material did not collapse at any moisture content (0% to 12%). Most of the field moisture contents measured at new bridge sites were within the bulking moisture content range making the backfill susceptible to collapse upon saturation. For a fill height of 3.0 m, a typical granular material would be expected to settle about 18 cm.

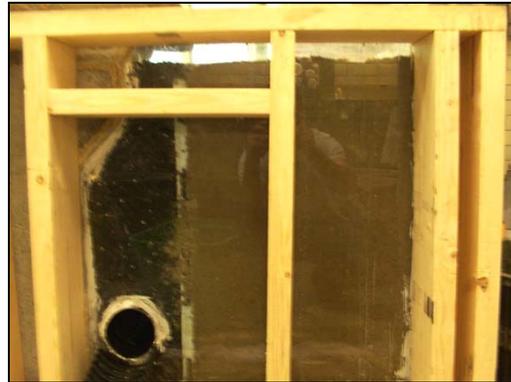
Figure 8. Using tire chips behind the bridge abutment

Similar to drainage detail No. 9, No. 12 (see Table 1), which uses tire chips behind the bridge abutment, showed good performance. The purpose of test No. 12 was to evaluate the use of tire chips as a drainage material, as well as its effectiveness in alleviating settlement and void development. Tire chips were placed behind the abutment without compaction over an 18 cm wide zone. For a separation barrier, a 2.5 cm thick foam board was placed between the tire chips and the granular backfill (see Figure 8). Granular backfill material was placed at a moisture content of 12%, and compacted in 5 cm lifts. An average relative density of about 70% was achieved. After four hours of running the test, the use of tire chips combined with saturated granular backfill eliminated settlement and void formation. The maximum steady state flow measured was 552 cm³/sec, which is 43% higher than the drainage detail No. 9 and 17 times higher than drainage details Nos. 1 through 3. Although 30% of the tire chips were smaller than the drainage pipe openings, none of the tire chips were washed out. Even though this drainage detail No. 12 resulted in the highest flow capacity, this detail may require more complex construction.

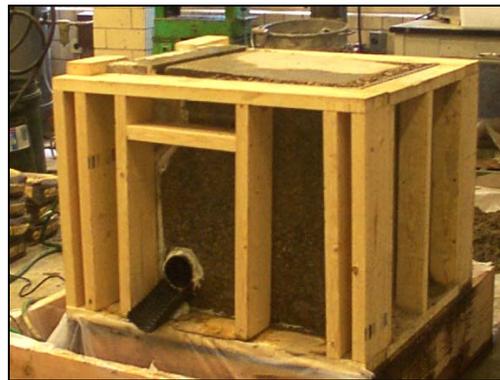
Figure 9. Using porous fill material behind the abutment

Another successful drainage detail was drainage model No. 13 (see Table 1), where porous backfill was used as a substitute for the granular material behind the abutment (see Figure 9). The drainage detail was evaluated based on the excellent performance of the porous material in the collapse test (no measurable collapse). The porous fill was placed at a moisture content of 4.6% and compacted every five cm to an average relative density of about 71%. The porous backfill prevented void formation and approach slab settlement. Furthermore, the maximum steady state flow measured was 92 cm³/sec, which is approximately three times higher than the maximum steady state flow measured using the current Iowa DOT specification drainage detail (Nos. 1 through 3). However, the maximum steady state flow was lower than the measured using a geocomposite vertical drain and tire chips. Despite the relatively low flow, drainage detail No. 13 can be applied at bridge sites due to its good performance and simple construction sequence.
