# Performance of SPS-1 Project in Kansas

The Long-Term Pavement Performance (LTPP) SPS-1 experiment entitled “Strategic Study of Structural Factors for Flexible Pavements” was developed to determine and evaluate the factors affecting the performance of flexible pavements. The experimental design was aimed at determining the effects of following specific pavement design features: (1) base type, (2) base thickness, (3) pavement thickness, and (4) in-pavement drainage systems. The SPS-1 experimental project in Kansas, constructed in 1993, was located in the eastbound driving lane of US-54, a major rural arterial. The experiment consisted of 12 standard SPS-1 sections, 1 Kansas DOT (KDOT) control section, and 5 supplemental sections. The service life of these sections was estimated by KDOT to be from 2 to 120 years. However, because of premature distresses, some sections were rehabilitated in 1996 and 1997. This paper discusses causes of premature distresses on some sections and the performance of other sections.

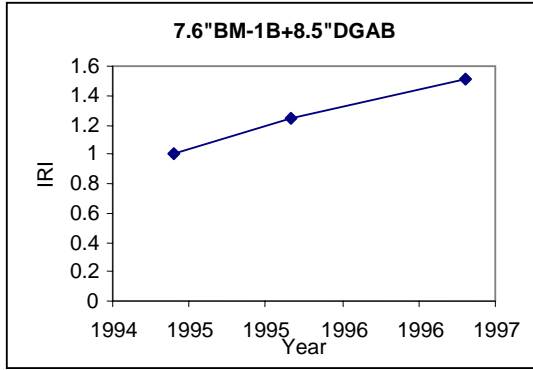
**Figure 11. IRI on section SHRP #1**

Sections SHRP #1 (7.6-in. BM-1B/8.5-in. DGAB), SHRP #2 (4-in. BM-1B/12.3-in. DGAB), and SHRP #4 (4.1-in. BM-1B/4.1-in. PATB/3.7-in. DGAB) indicated rutting as well as map or alligator cracking. Section SHRP #2 (4-in. BM-1B/12.3-in. DGAB) had one-inch-deep ruts in both wheel paths in 1996. It was suggested that a four-inch mill and inlay be used if the deterioration continued. The deficiencies mentioned above were summarized by the KDOT Geotechnical Unit in Table 3.

Sections KDOT #3 (1.5-in. ARS/9.9-in. BM-2C) and KDOT #5 (1.5-in. ARS/2.5-in. ARB/8-in. DGAB) were milled and overlaid in December of 1995. Test sections KDOT #6 (1.5-in. ARS/2.5-in. ARB/8-in. BM-2C), SHRP #1 (7.6-in. BM-1B/8.5-in. DGAB), SHRP #2 (4-in. BM-1B/12.3-in. DGAB), and SHRP #4 (4.1-in. BM-1B/4.1-in. PATB/3.7-in. GAB) showed signs of rutting along with block cracking and were repaired in the summer of 1996.

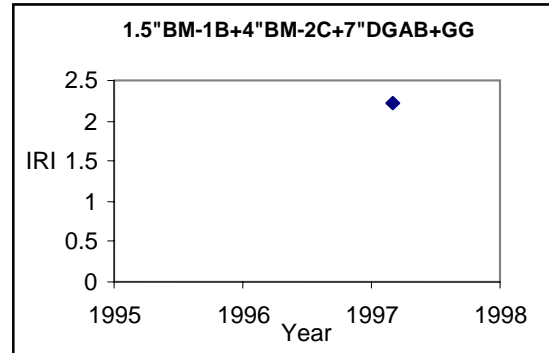
**Figure 13. IRI on section KDOT #1**

Sections KDOT #1 (1.5-in. BM-1B/4-in. BM-2C/7-in. DGAB/GG) and KDOT #2 (1.5-in. BM-1B/4-in. BM-2C/11-in. DGAB) were observed to have major cracking problems. The DGAB fines appeared through the cracks in the ruts. These sections had indicated rutting failure and cracking. Laboratory testing on the cores showed that the rutting in section KDOT #1 (1.5-in. BM-1B/4-in. BM-2C/7-in. DGAB/GG) was due to unstable surface and base layers. KDOT #1 and KDOT #2 were milled up to four inches and inlaid with a BM-2 mix in 1997. A three-inch BM-2 overlay was then placed on both sections.
